Report of Investigation in  
the Matter of Sinking of  
Passenger Vessel EXPLORER (O.N. 8495)  
23 November 2007  
in the Bransfield Strait near the South Shetland Islands

**26 March 2009  
Monrovia, Liberia**

Report of Investigation into  
the Sinking of  
Passenger Vessel EXPLORER  
23 November, 2007  
in the Bransfield Strait near the South Shetland Islands

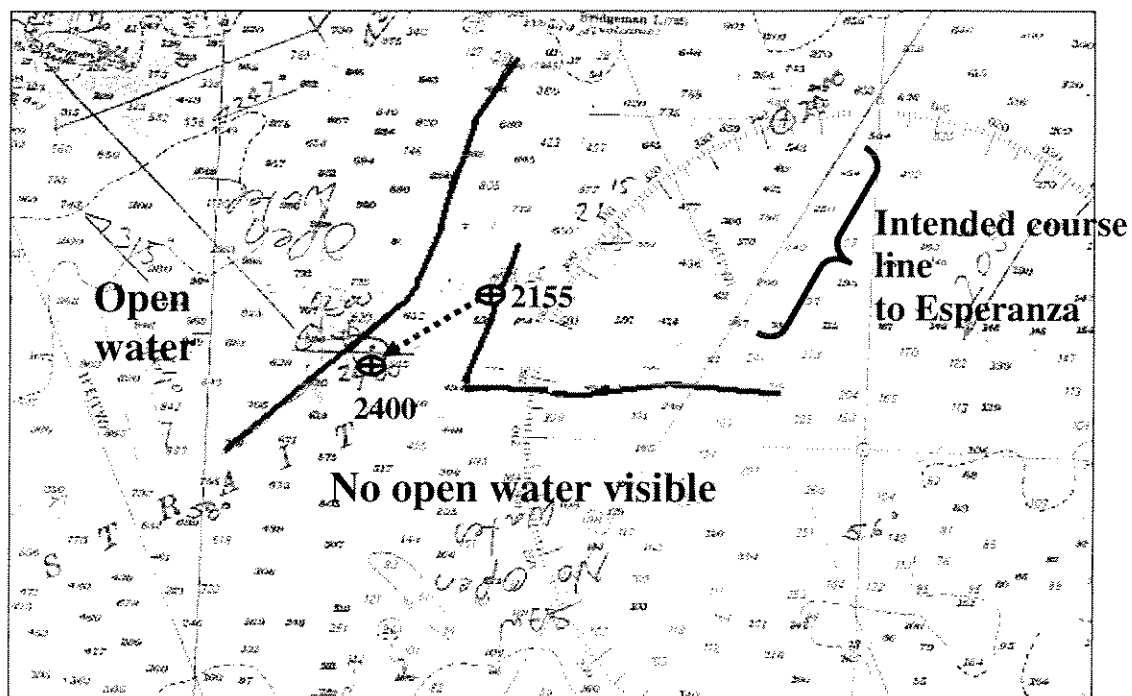
Chart 1: Navigation Chart marked by 2000-2400 Safety Officer.  
Navigation track indicated by 2155 .....→2400 while EXPLORER was in ice field.

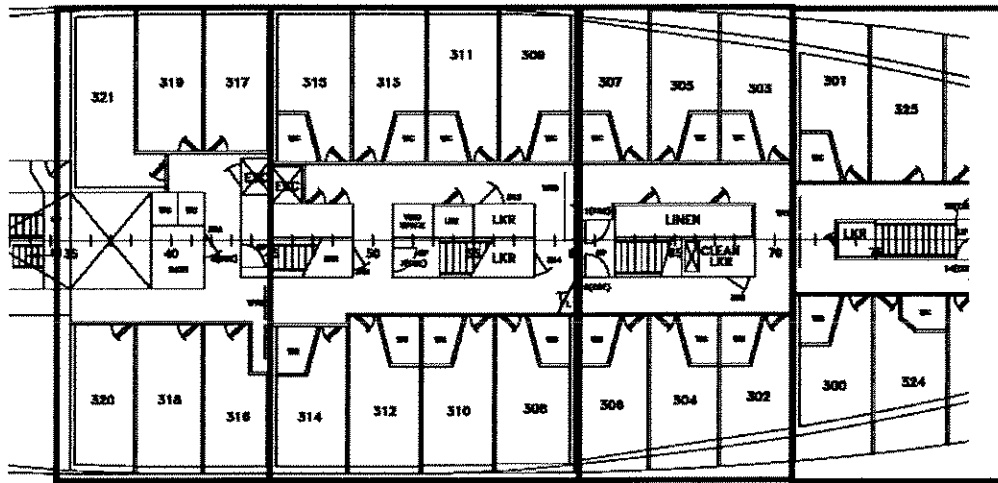
Graphic 3: Cabins on 300 Level. The vessel bow is to the right of the page and stern is to the left of page. Port side is to top of graphic (odd numbered cabins) ; Starboard side is on bottom (even numbered cabins) Cabin 314 is where crewmember reported feeling “fist sized hole”. The four compartments are indicated in the rectangles.

The two crewmembers working in cabin 314 could not locate the source of the flooding because of the decorative paneling of the cabin which covered the side plating of the vessel. There was an inspection access panel beneath the bunk bed that the men removed to determine the location of the damage. When they still could not locate the source of the flooding, they decided to remove the bunk bed which they realized would have to be removed to also remove the bulkhead paneling. Both men said that the water level was higher along the bulkhead indicating that the vessel had begun to list. To remove the bunk bed, the Oiler had to use a ratchet wrench with extension to loosen the bolts that held the bunk in place. The bolts were submerged by the cold seawater making it difficult for the crewmen to reach into the water and feel for the head of the bolts. He said that at one point his hands had become numb from working in the cold water and was not certain if he was succeeding in removing the bolts. However, after successfully removing the bolts and moving the bunk away from the bulkhead panel, the two men used a fire axe and tore out a 60 cm wide by 80 cm high section of panel.

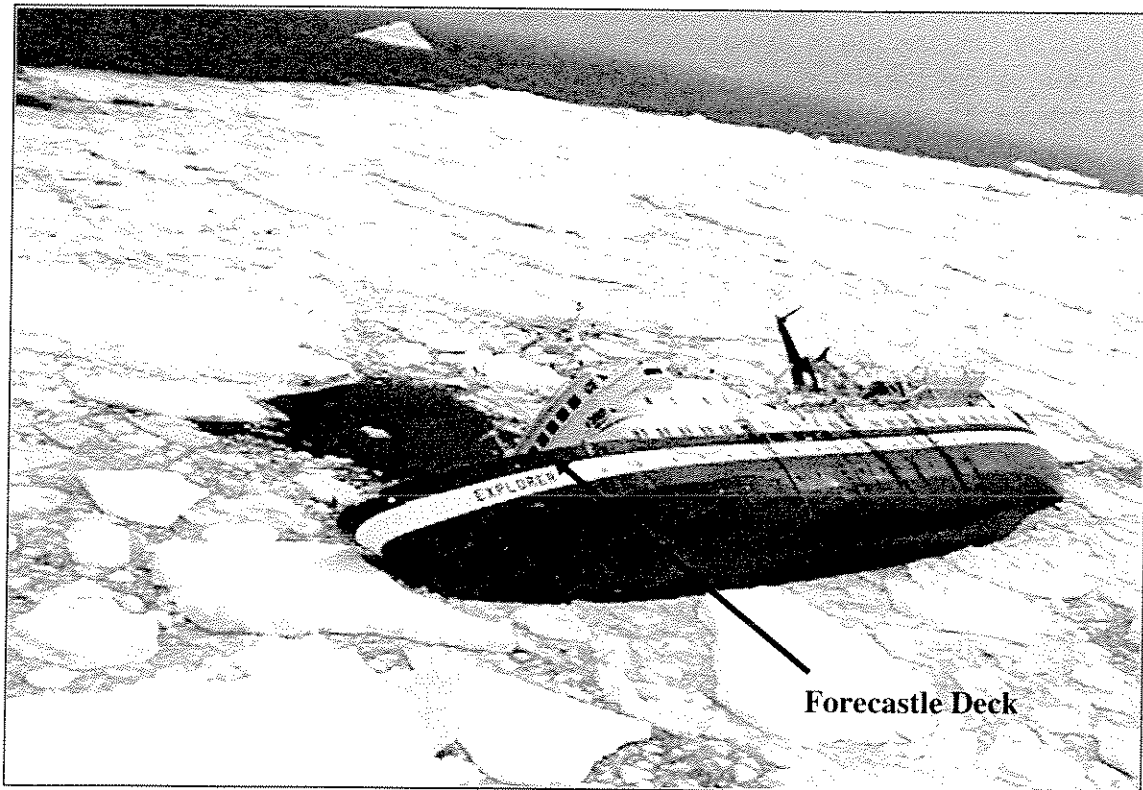
Photo 2: EXPLORER after all passengers and crew had been evacuated from vessel. Note black streak above keel - See section – Sewage Holding Tanks.

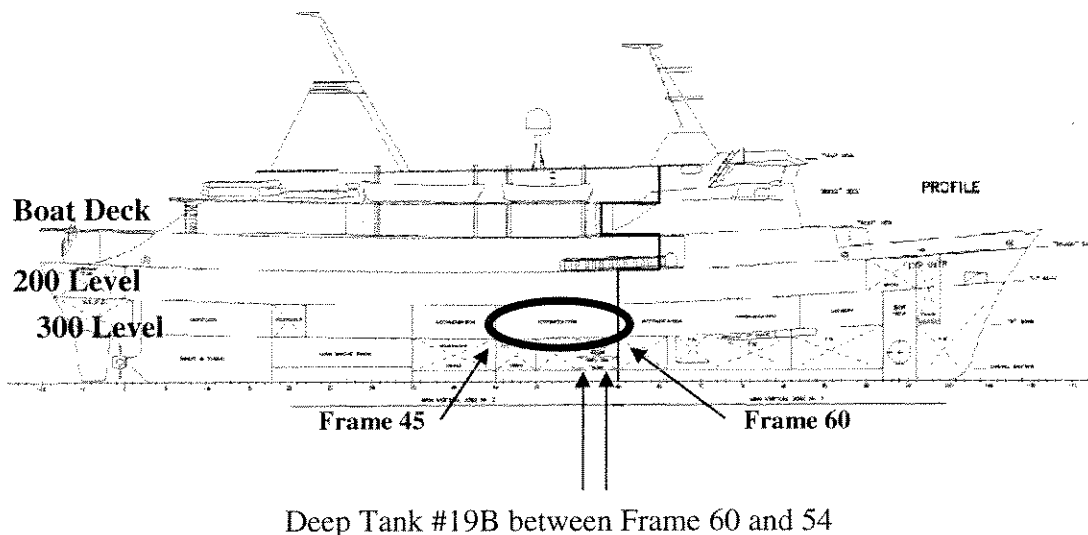
| Graphic 4: Profile View with Passenger Levels | |

| | Passenger cabins located between Frame 45 and 60 on 300 Level were flooded. Frame spacing was 600 mm between each frame. |

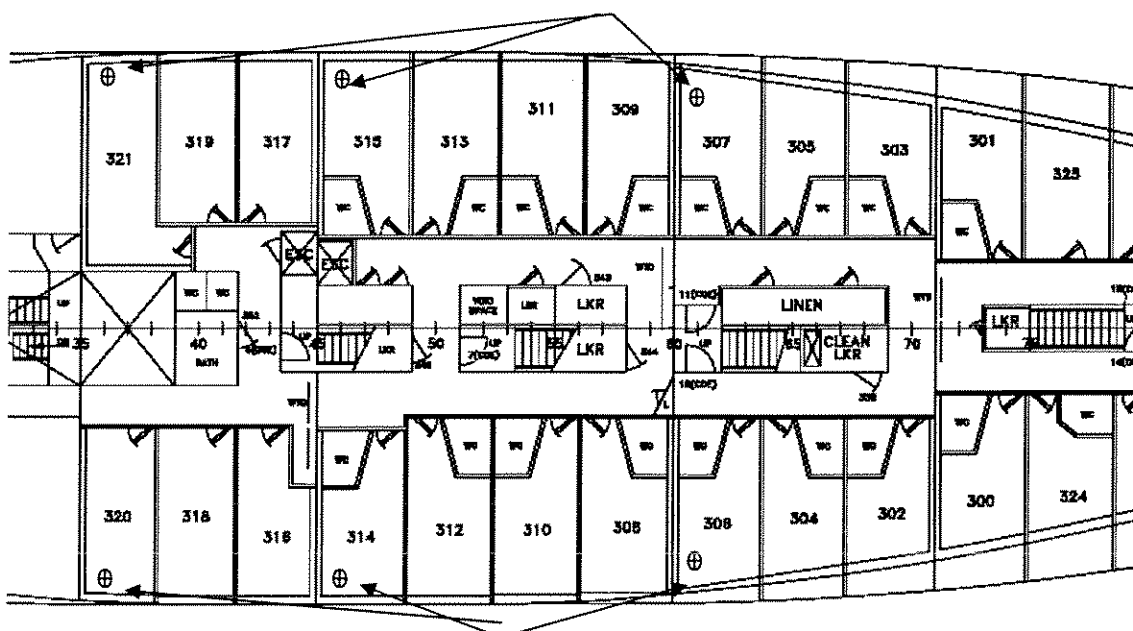
As indicated in Graphic 5, there were six ducts below the bunks or settees. The devices consisted of a plate with a spring-loaded hinge on one side of the plate that kept the plate in a closed position until the water level in the passenger cabin reached a certain level. The weight of the water would cause the plate to open and water would drain into the Engine Room. The Chief Engineer stated that the engine crew had to periodically perform maintenance on the hinges, usually after hearing complaints from the passengers. The sewage treatment tanks were located in the engine spaces and would vent gas and create an unpleasant atmosphere in the passenger cabins if the plate was not completely closed.

Graphic 5 : Down flooding ducts indicated by arrows.  
Stern of vessel is to left of page and Bow is to the right. Even numbered cabins on the starboard side of the vessel; Odd numbered cabins on the port side of vessel

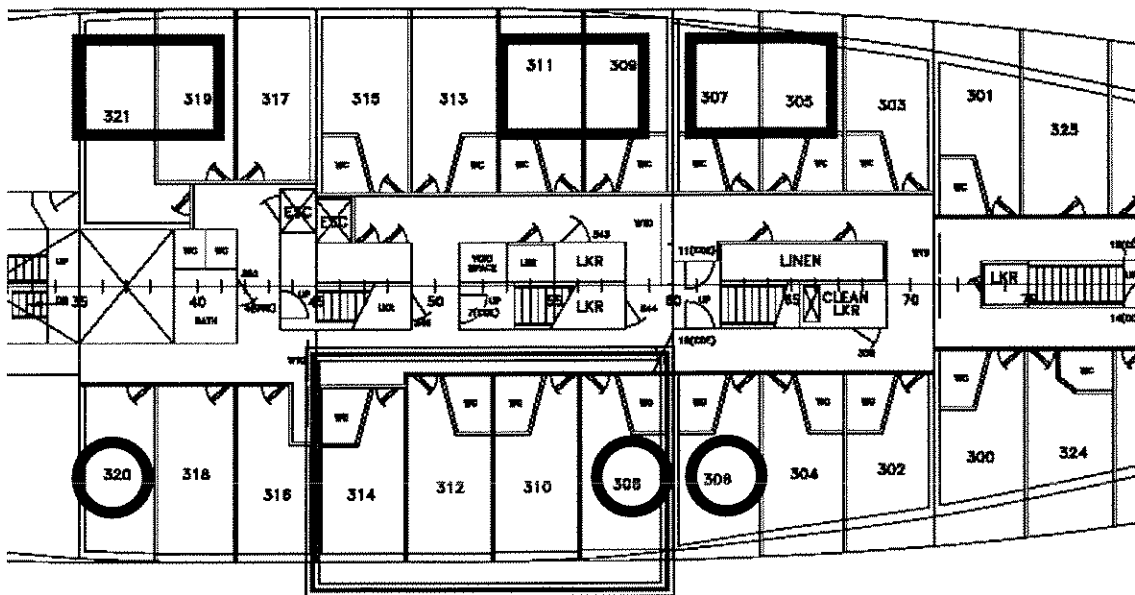
Graphics 6 :Rectangles in graphic below indicate cabins adjacent to where shell indentations were found and shell plating was replaced on the port side of vessel.

inspect specific areas on the starboard side. The decorative bulkhead paneling was removed in cabins 306, 308, 320 and additional gauging of the deck plating was conducted. There were no abnormalities to the frames and shell plating noted, but corrosion of the deck plates was visible.

Dark circles indicate where surveyor had paneling removed to inspect deck plating on starboard side.

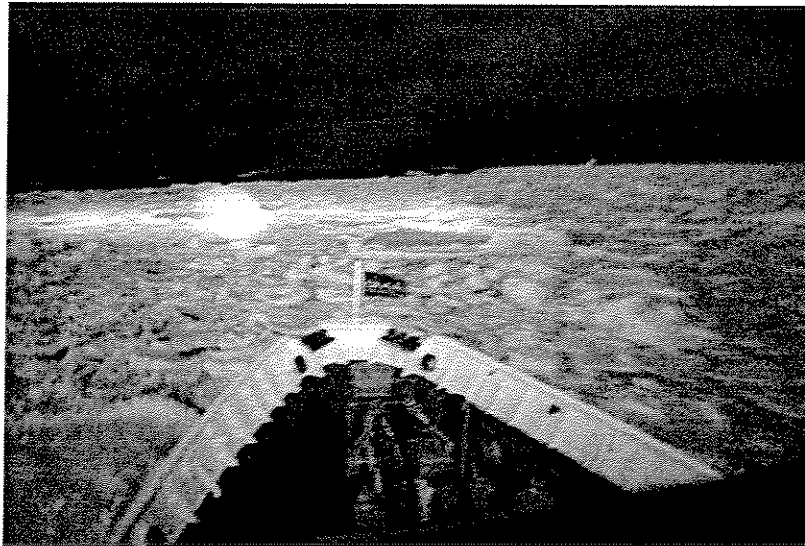
23/11/07 Time: 4:02 Taken from the Bridge. I felt uneasy as the ridge was getting nearer so did not take this picture very well. I was going to take another photo but we were up to the ridge and I held on to a pole in front of me. The ship hit the ridge hard and it felt like it came to a stop. It was very shortly after this that the passenger alarm went off, the Captain checked the damage, sounded the muster alarms it was then I left the Bridge
