# UNITED STATES COAST GUARD

## REPORT OF INVESTIGATION INTO THE FIRE ONBOARD THE CARNIVAL SPLENDOR WHICH OCCURRED IN THE PACIFIC OCEAN OFF THE COAST OF MEXICO ON NOVEMBER 8, 2010, WHICH RESULTED IN COMPLETE LOSS OF POWER

MISLE INCIDENT INVESTIGATION ACTIVITY NUMBER: 3897765

16732  
July 15, 2013

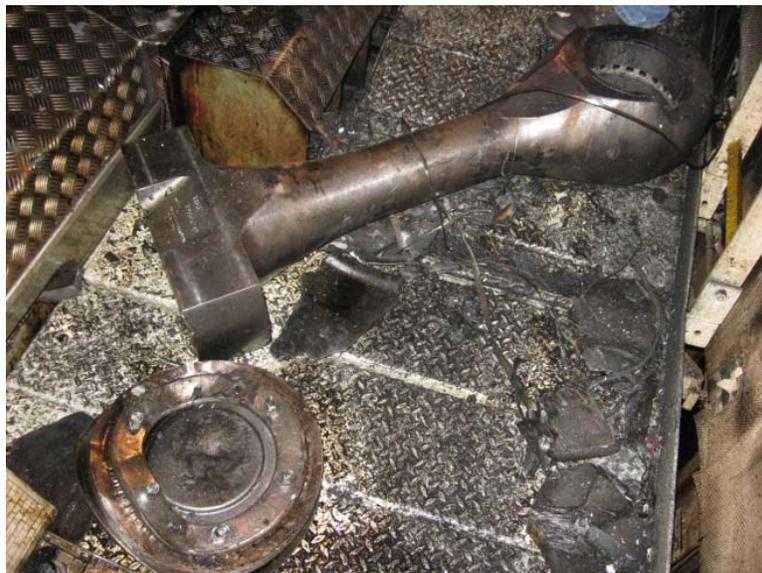
Post-casualty inspection of the DG 5 prime mover revealed a catastrophic failure primarily involving the components of one set of cylinders. The failures of the two connecting rod and piston assemblies in the A1 and B1 locations on DG 5 destroyed the engine so that it was no longer usable. The connecting rod upper components sheared from the connecting rod lower parts on two cylinder sets. Connecting rod upper part B1 was in two pieces in the oil sump, while connecting rod A1 (780 lbs) had ejected out of the crankcase.

**Photograph 1 - Connecting rod, upper part A1 (780 lbs) ejected from DG5 and found on deck plates in aft engine room.**

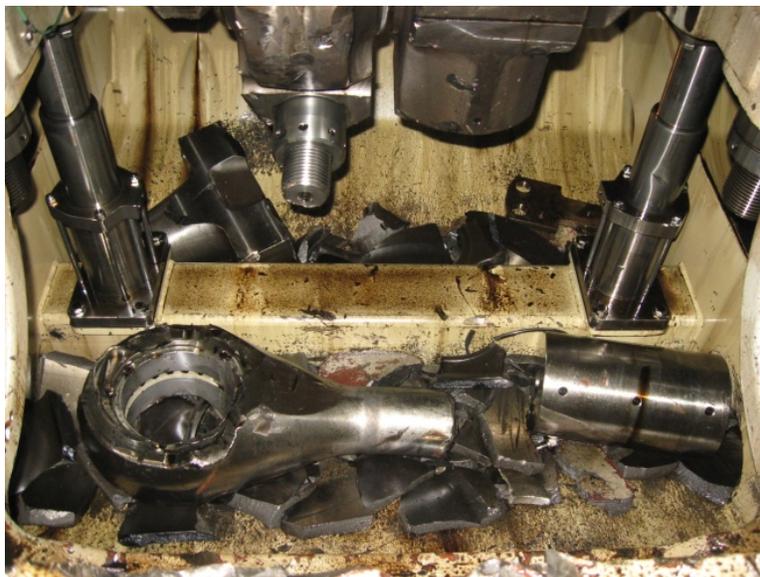
**Photograph 2 - - Connecting rod, upper part B1 in two pieces found in the oil sump**

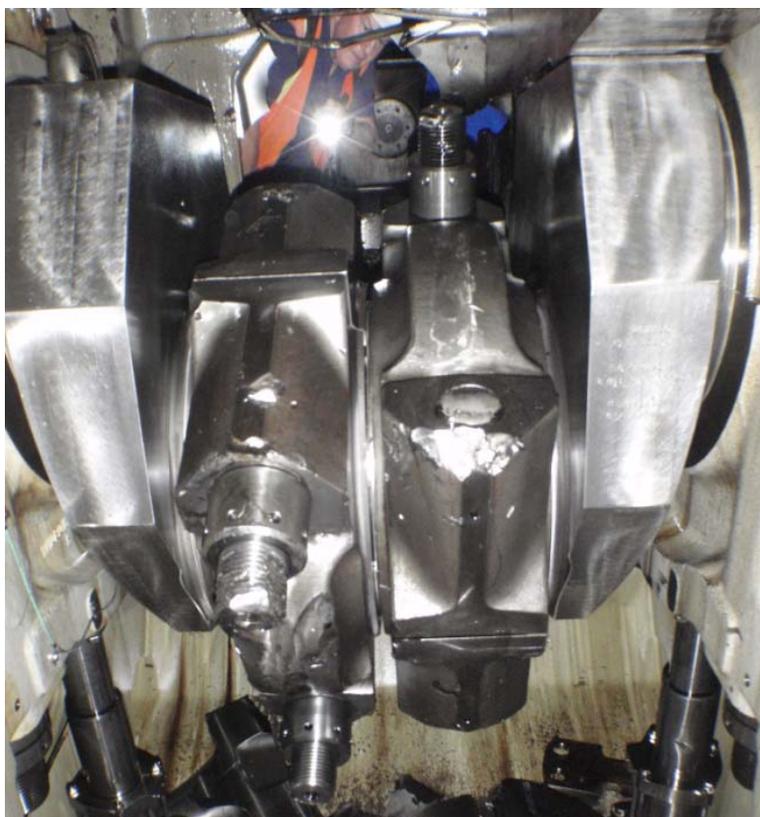
**Photograph 3 - Lower halves of A1 and BA connecting rods for DG5, each were seized on the crank pins (crankshaft journals).**

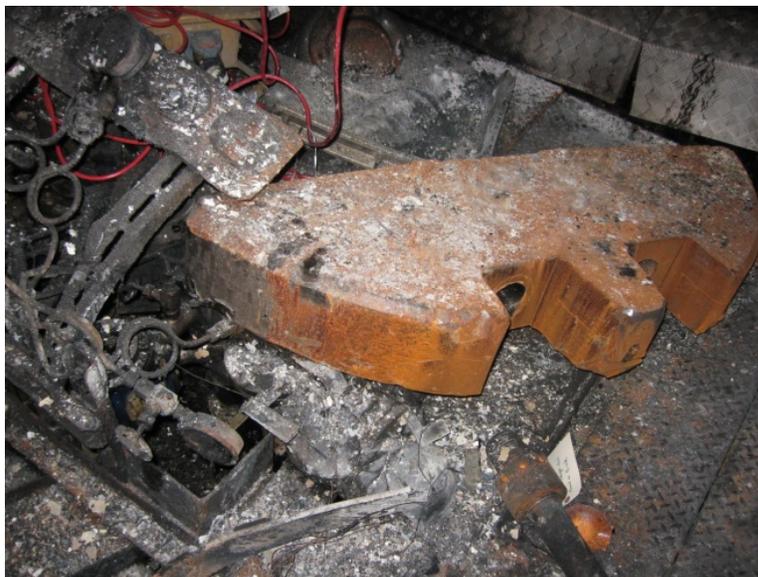
**Photograph 4 - Crankshaft counterweight from DG5, A1/B1 cylinder. Counterweight was ejected from engine and landed between DG5 and DG6 in the primary burn area.**

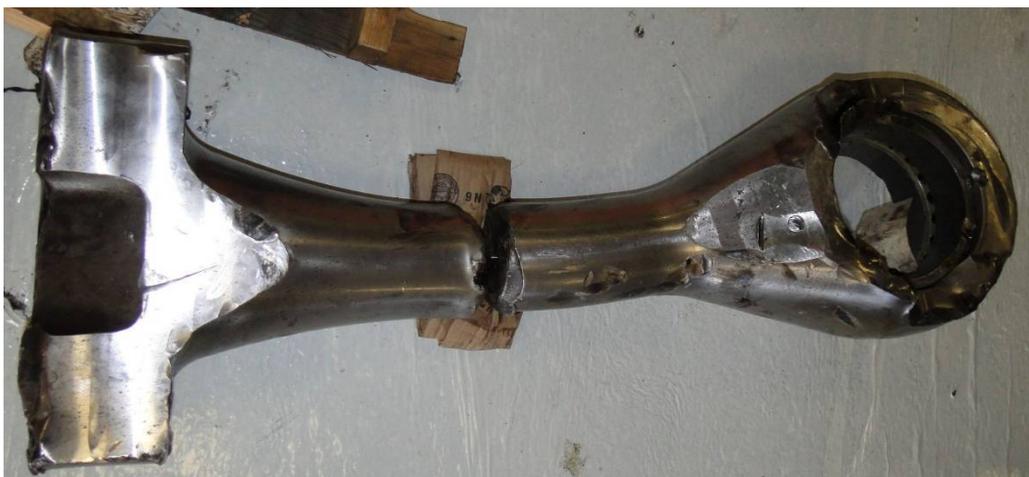
**Photograph 5 - B1 Connecting Rod for DG5  
Post-casualty photo provided by Wartsila**

*“Results of the evaluation conducted indicated that the subject connecting rod failed by progressive fracture in the nature of high cycle, low stress fatigue. The origin of the connecting rod fracture could not be determined due to the severe impact damage to the fracture surface. Nevertheless, the crack origin of a secondary fatigue crack evident approximately 5.5 in. above the primary fracture surface was determined to be at the*

*extrados of the bent connecting rod shank. This indicated that the fatigue crack most likely initiated as a result of increased surface stresses at the extrados after the connecting rod shank was bent. It further indicated that it is likely that the fracture origin of the primary fracture was also located in an area of raised surface stress at or near the connecting rod extrados.”*

LPI reported that the stress state in the connecting rod was “not present from the beginning of the diesel engine's service life” and that the “bend in the connecting rod shank elevated surface stress in the shank to a sufficient level to initiate fatigue cracking which propagated and caused the connecting rod to fracture.”

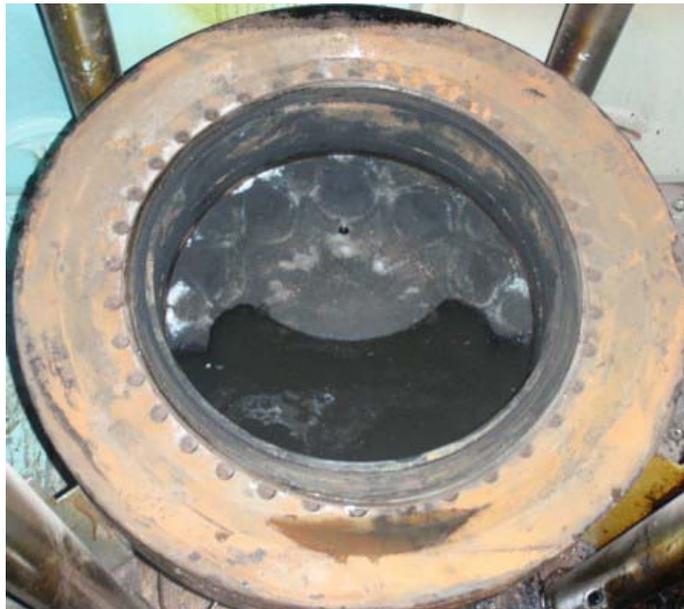
Photograph 6 (below) was taken by Carnival employees during the head gasket replacement. The cylinder surfaces show significant carbonization which indicates incomplete combustion. While this phenomenon may have been attributed to a bent connecting rod, the engineers involved in the work did not make that diagnosis, and did not observe any problems with the engine which led them to believe there were issues with the B1 connecting rod.

**Photograph 6 - DG5, B1 cylinder liner, piston crown and gasket  
Photo taken by Carnival employees during head gasket replacement on November 5, 2010**

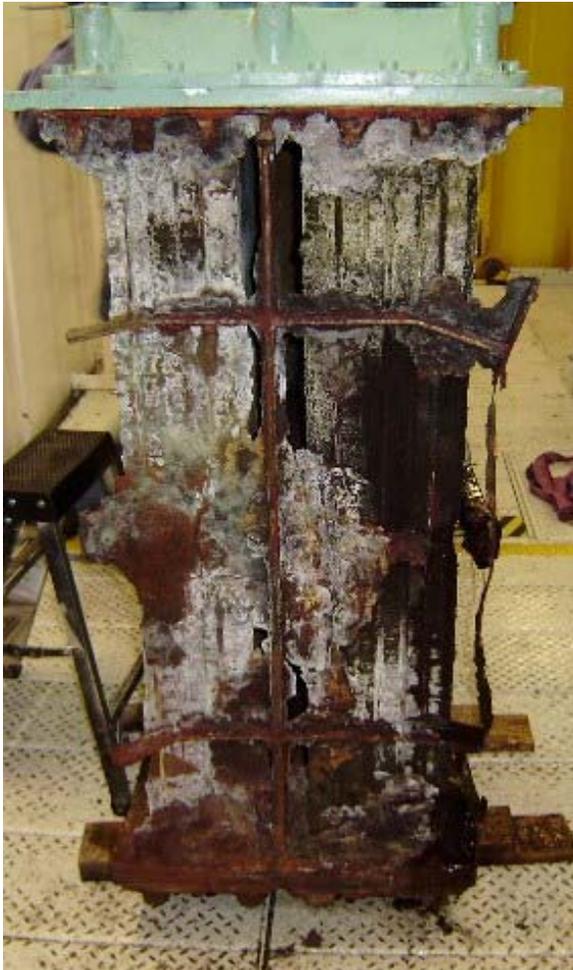
Onboard the Carnival Splendor as recently as July 12, 2010, the B bank of DG5 was discovered to have a severely corroded, destroyed and leaking air cooler heat exchanger. The cause of the corrosion was suspected to be: 1) failed drainage of the condensate formed on the outside of the tubes and away from the heat exchanger, 2) a leaking heat exchanger tube, and 3) backflow from other operating engines when the engine is secured or during temporary exposure from other leakages such as when the exhaust gas boiler flooded back to the engine during refilling. Photograph 7 shows the bottom of the heat exchanger having rusted away almost a complete steel 27 plate between its frames. Photograph 8 shows the plate of a new heat exchanger having slightly different construction.

**Photograph 7 - Corroded heat exchanger from DG5.**  
Photo provided by Wartsila, taken on July 12, 2010

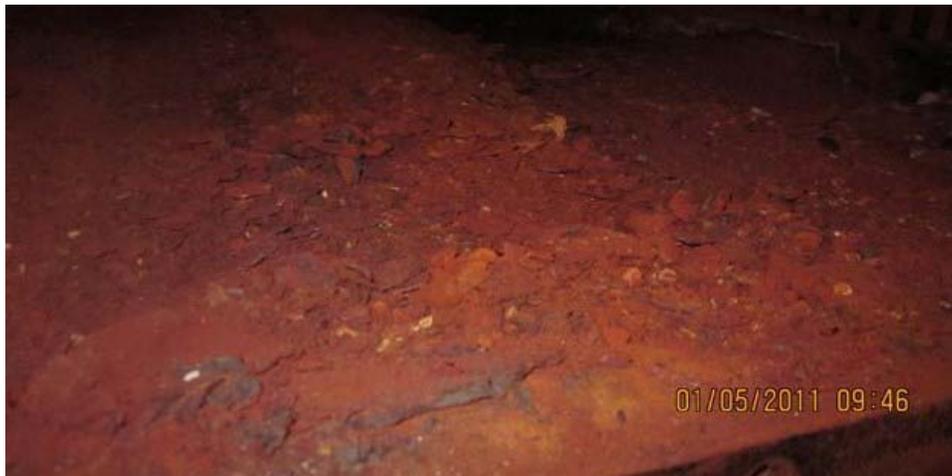
Post-casualty inspection of the DG5 air coolers revealed significant quantities of ferrous oxide scaling and rust in the air cooler base area and outlet areas of the B side of DG 5 air cooler, as shown in Photograph 9 and Photograph 10. The heat exchangers were tested and found not to be leaking. The receiver runs the length of the engine and connects to the air inlets of both banks of heads. In Photograph 11, scale is shown in a drain valve connection on the pressure side of the orifice when the engine is running. There is no evidence of screens or other devices to protect against the clogging of the drains by rust particles within the air cooler. Photograph 12 provided by Carnival shows the sight glass of the B1 cooler. The sight glass developed a visible haze over the inspection port which obstructed the viewing port and made observation of water flow very difficult.

**Photograph 9 - DG5 air cooler, outlet area**

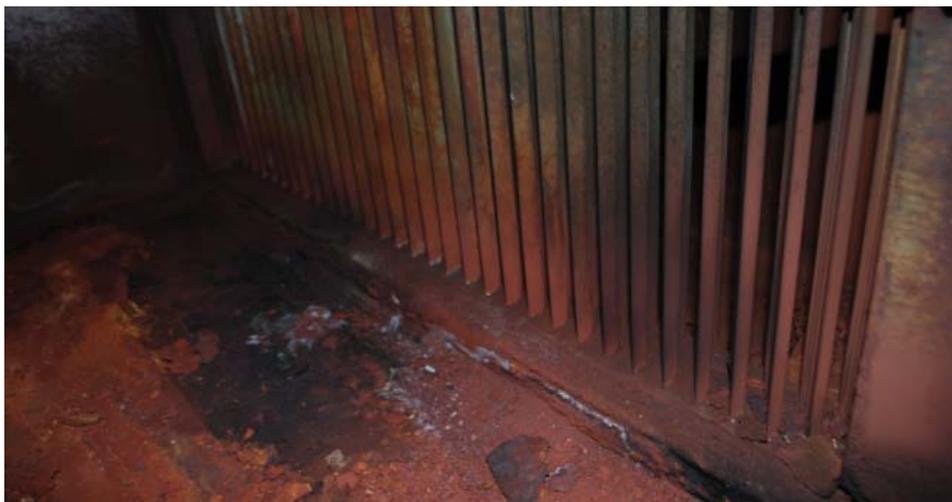
**Photograph 10 - DG5 air cooler, outlet area**

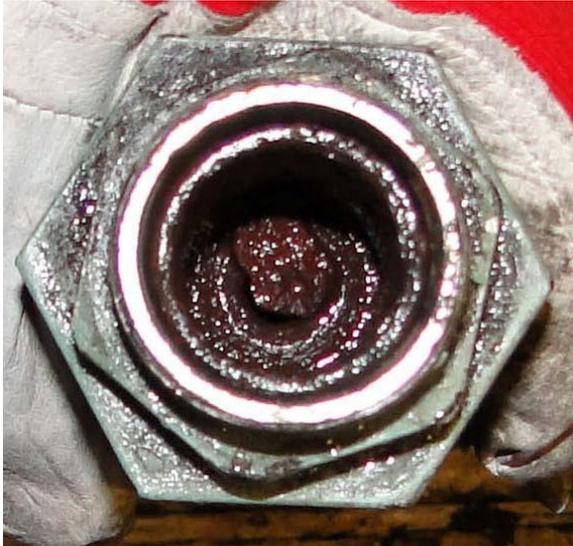
**Photograph 11 - DG5 air cooler, drain valve connection.**

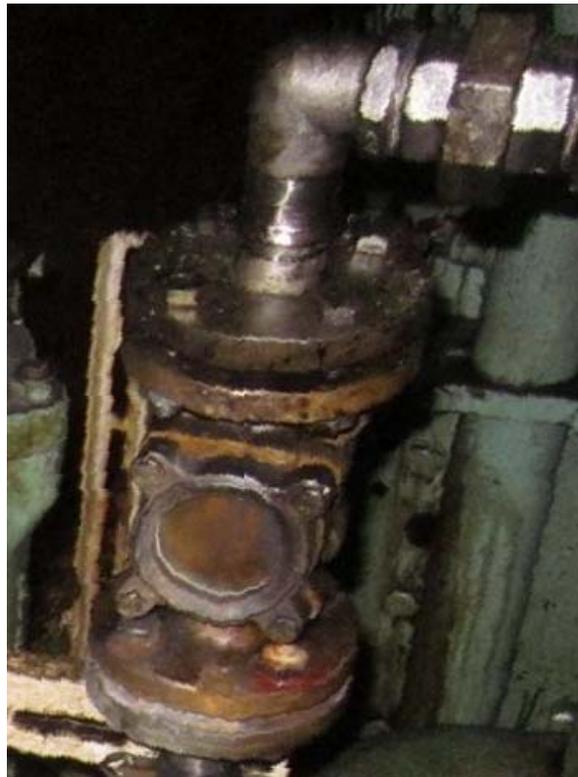
**Photograph 12 - DG5 air cooler, sight glass for B1 cooler.**

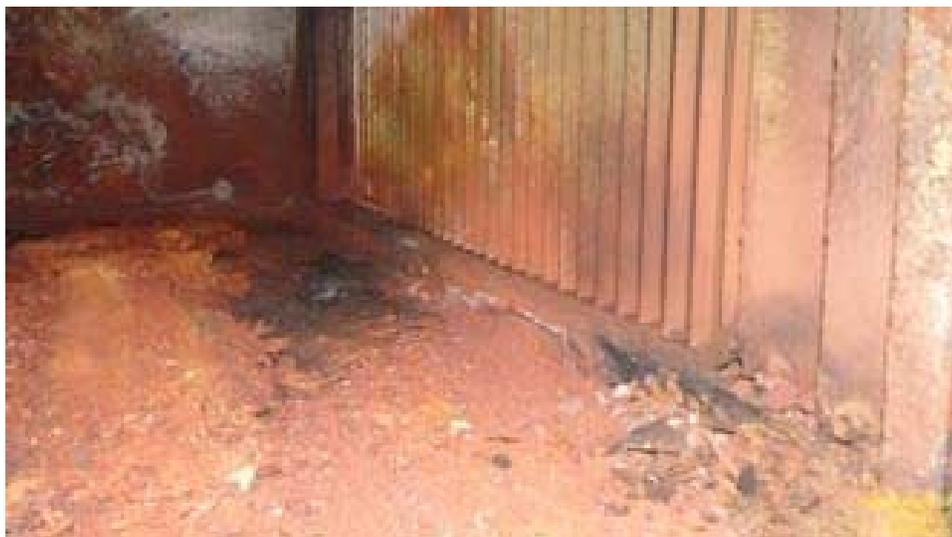
Post-casualty, the A side of the DG5 air cooler was also found in a stage of deterioration. Its casing area was also heavily contaminated with ferrous oxide/rust. Its base also showed significant evidence of deterioration.

**Photograph 13 - DG5, A side air cooler.  
Photo taken by Wartsila**

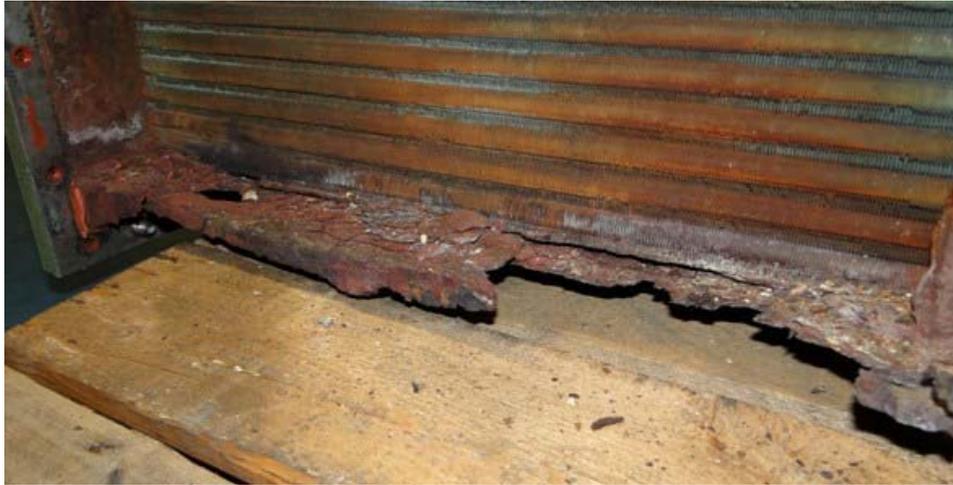
**Photograph 14 - DG5, A side air cooler.**  
**Photo taken by Wartsila**

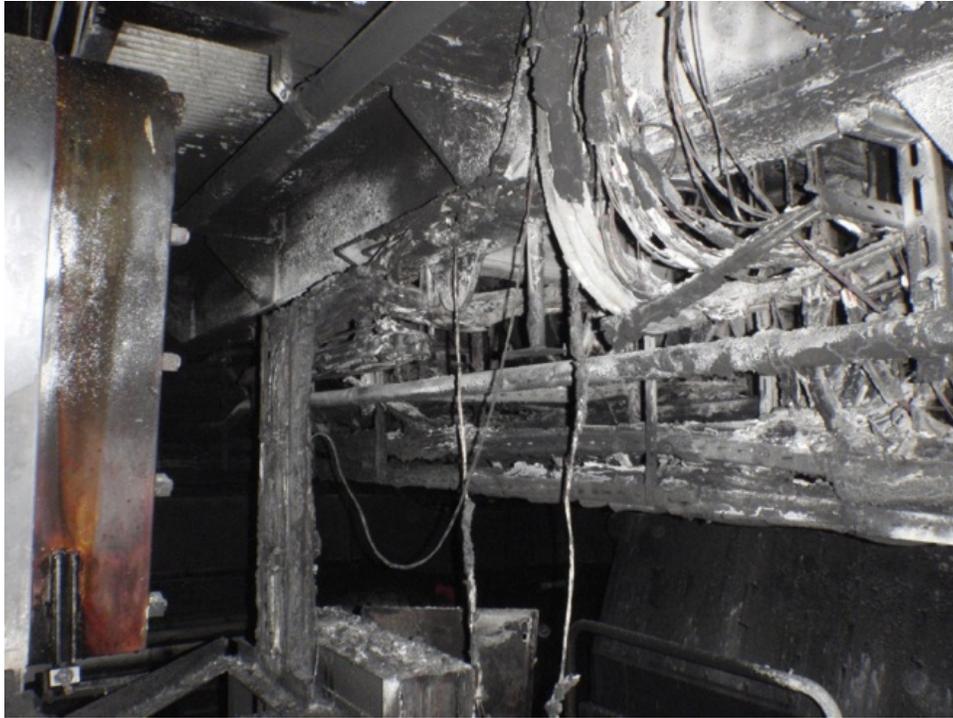
**Photograph 15 – Rear section of DG5**

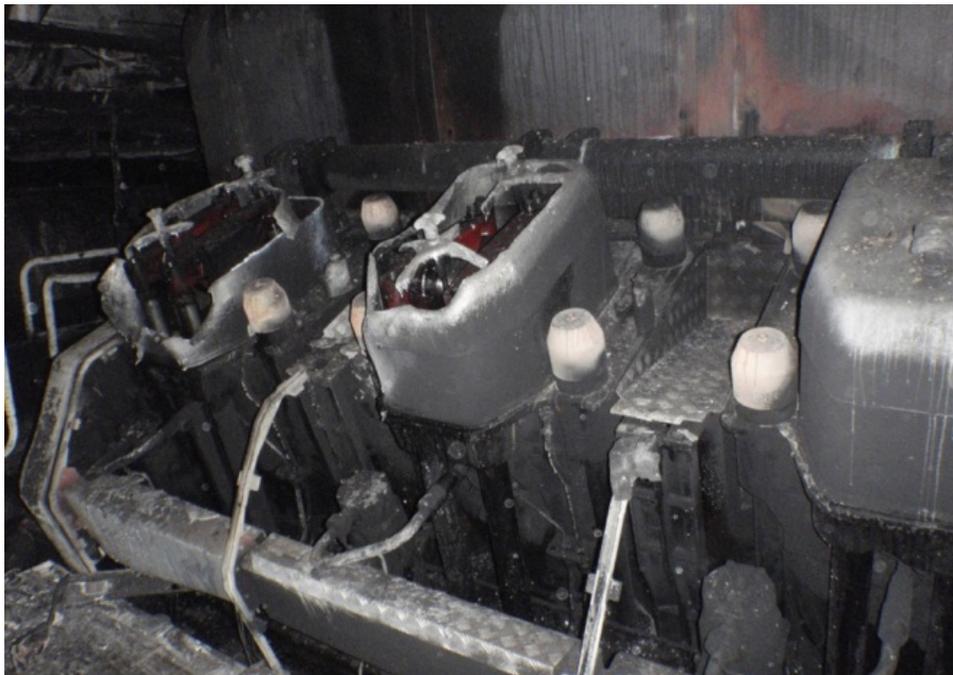
**Photograph 16 - DG5 valve covers, B1 and B2 cylinders**

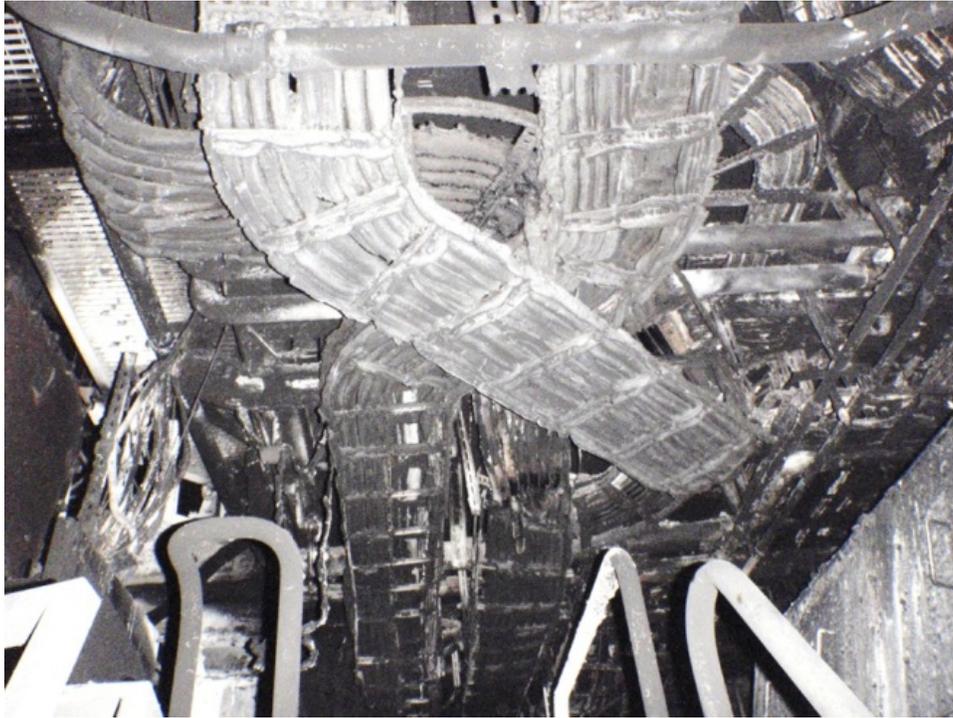
**Photograph 17 – Overhead cable runs between DG5 and DG6**

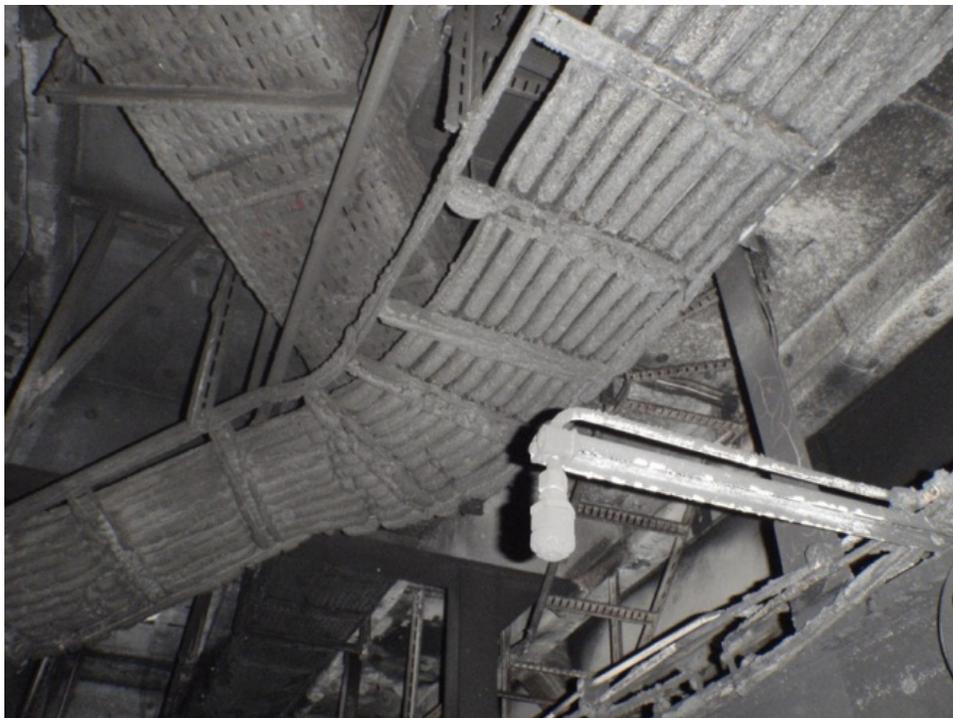
**Photograph 18 – Overhead cable runs above DG5 and DG6  
Note the location of the Hi-Fog nozzle below the cables runs**

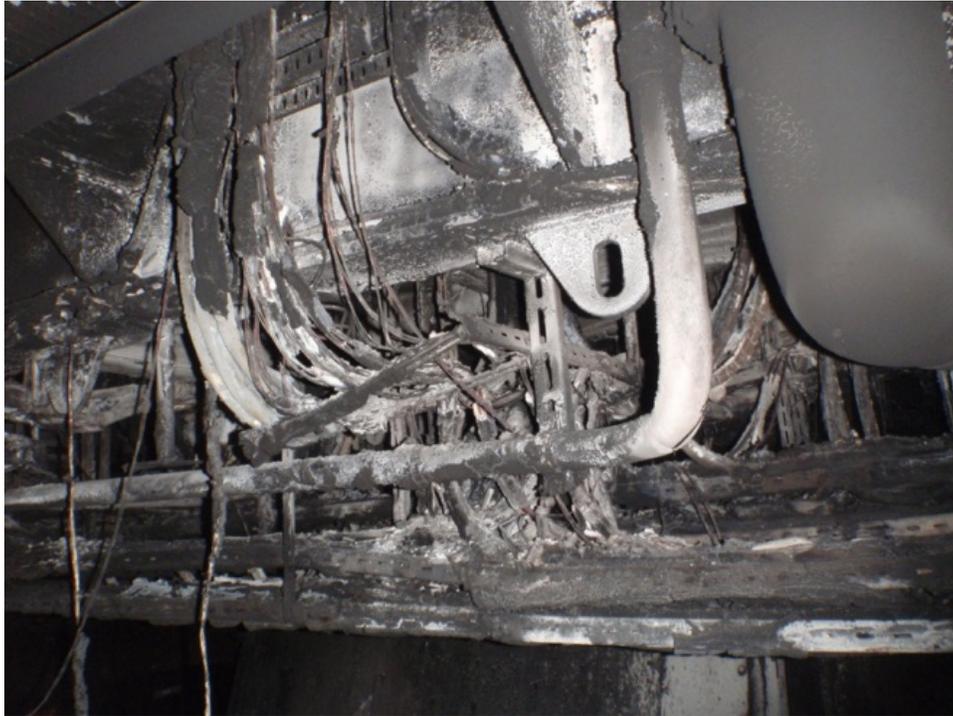
**Photograph 19 – Vertical cable runs; note bare cables due to fire damage**

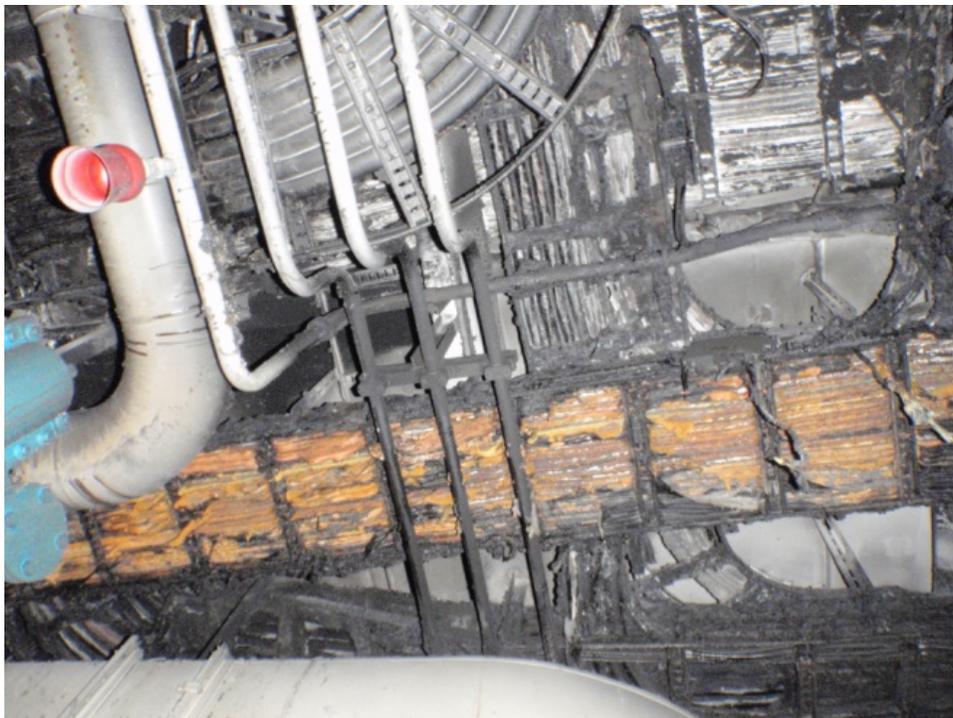
**Photograph 20 – Cables above DG4 showing melted orange cable covering**

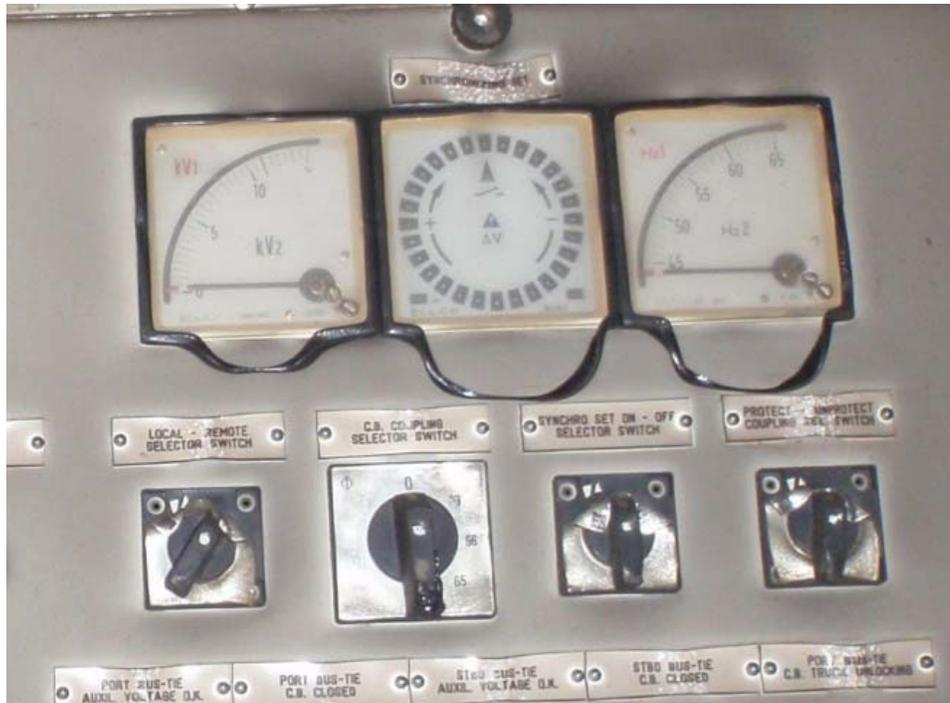
**Photograph 21 – Console in starboard switchboard room showing melted plastic components.**

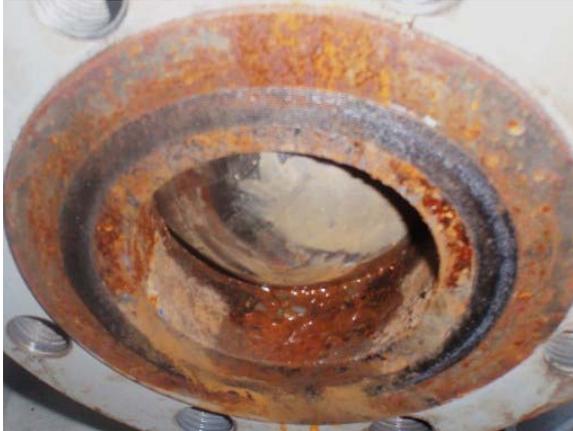
When the piping segment associated with the discharge leading to the aft machinery space was taken apart a small amount of moisture drained out and some corrosion was noted (see

**Photograph 22 - CO2 system, 3-inch ball valve to aft machinery spaces**

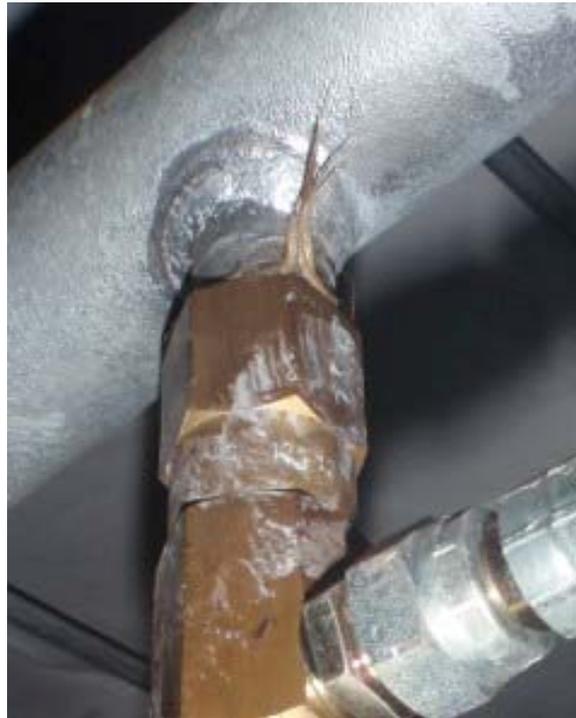
**Photograph 23 - Photo showing hemp packing in CO2 system fittings**

Many connections using hemp leaked. In one control cabinet, the control valve handles had been incorrectly fitted. A number of the fasteners securing the actuating arms to different control valves were discovered loose.
