Report of Investigation in  
the Matter of Sinking of  
Passenger Vessel EXPLORER (O.N. 8495)  
23 November 2007  
in the Bransfield Strait near the South Shetland Islands

**26 March 2009  
Monrovia, Liberia**

Report of Investigation into  
the Sinking of  
Passenger Vessel EXPLORER  
23 November, 2007  
in the Bransfield Strait near the South Shetland Islands

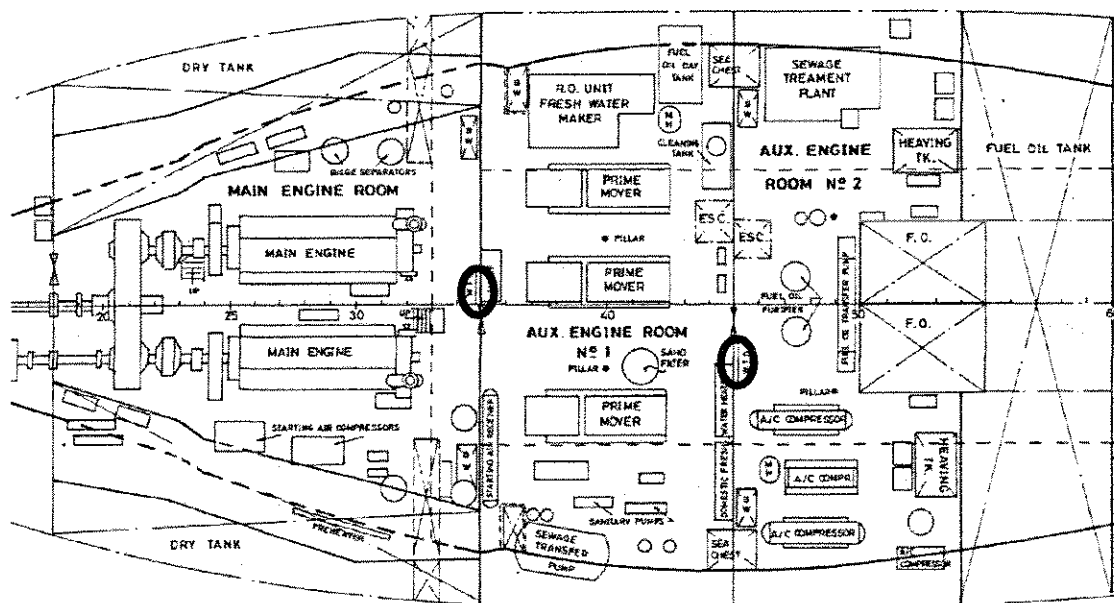
Graphic 2: Engine Room – Machinery Spaces

In the Engine Control Room, the Second Assistant Engineer was finishing up his regularly assigned 2000 to 2400 watch. While making entries into the Engine log book, he heard a loud bang. He estimated the time to be about 2350. He sent the Oiler to make an inspection round of the Engine Room spaces. The Oiler left the Control Room and when he returned he told the Second Assistant Engineer that water was entering the Separator Room. (See Graphics 2: Engine Room diagram below)

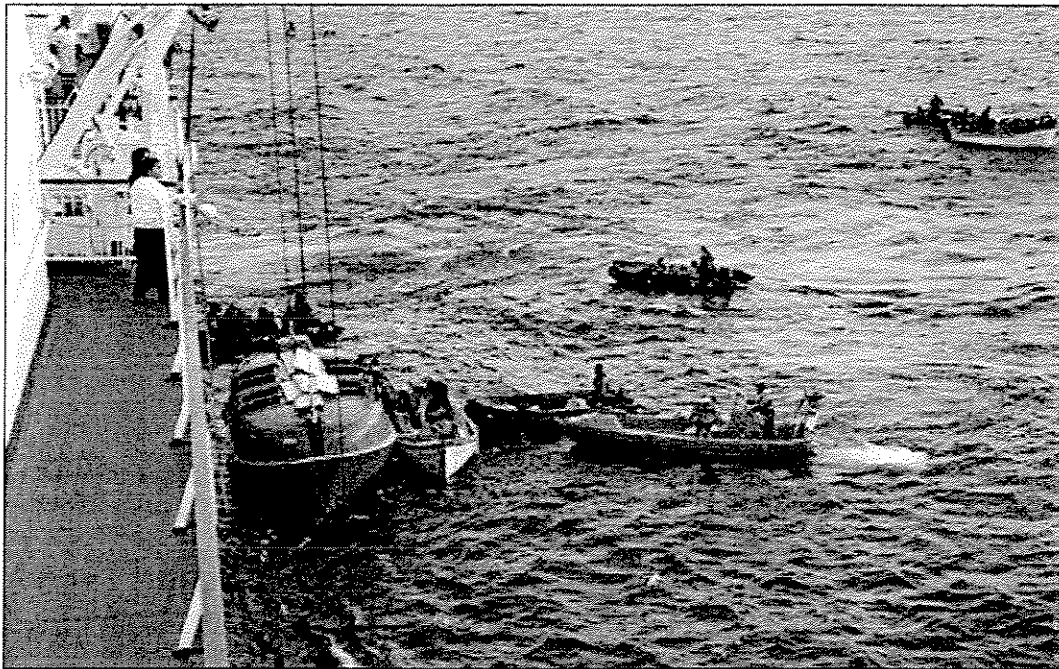
Photo 4: Transferring of Passengers to lifeboat of NORDNORGE.

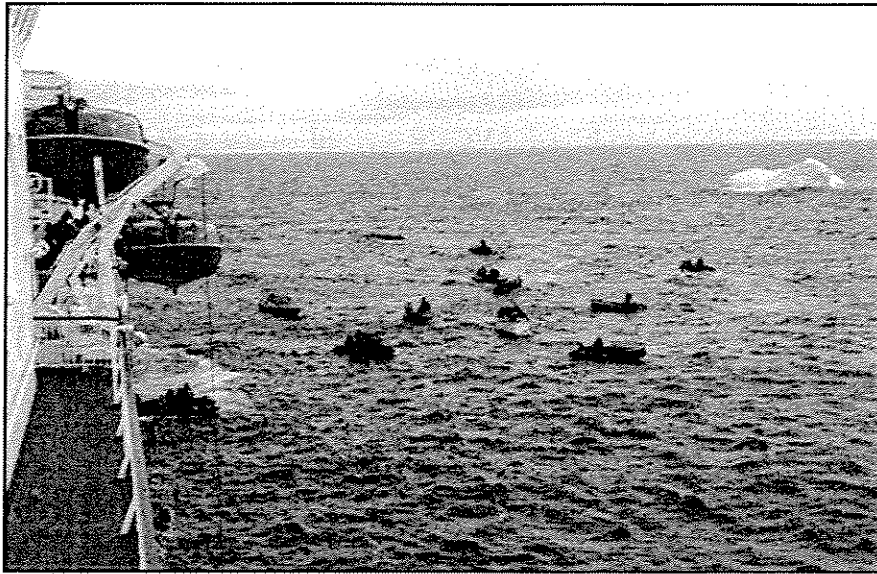
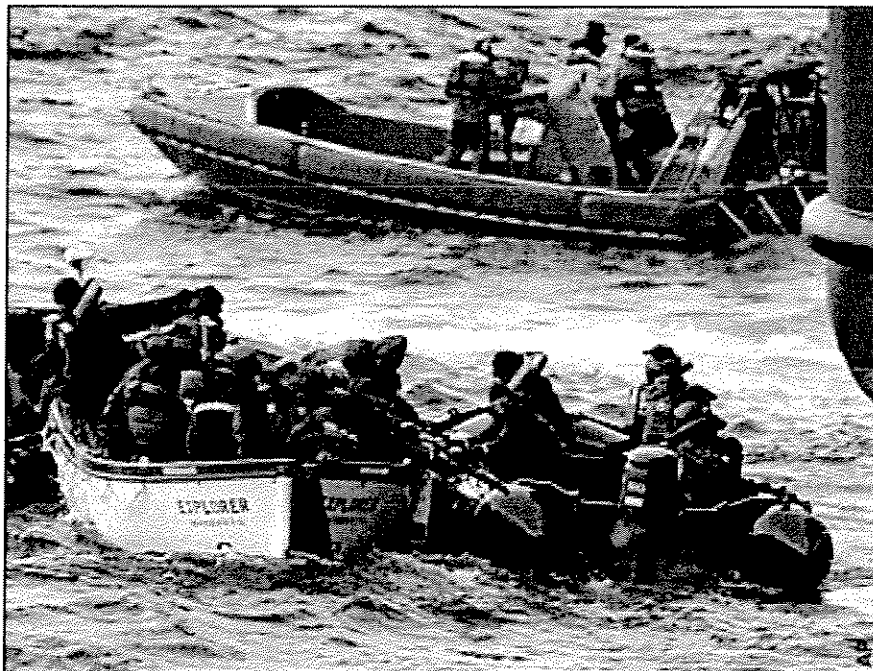
The passengers that had to board the NORDNORGE from the Zodiacs had a more difficult and risky procedure. For the transfer, the Zodiac driver maneuvered the bow of the Zodiac against the NORDNORGE in the location of the NORDNORGE's sideport. Passengers had to reach from the Zodiac and grab a "rope ladder" (Jacobs ladder) that was hanging from the sideport. (See Photo 5) Some passengers were reported to be too cold to climb the ladder and other passengers and crew had to assist by pushing and pulling the passenger into the sideport.

Photo 5 above: Zodiacs at sideport ladder of NORDNORGE.  
Photo 6 below: transferring passengers from Lifeboats to Zodiacs.

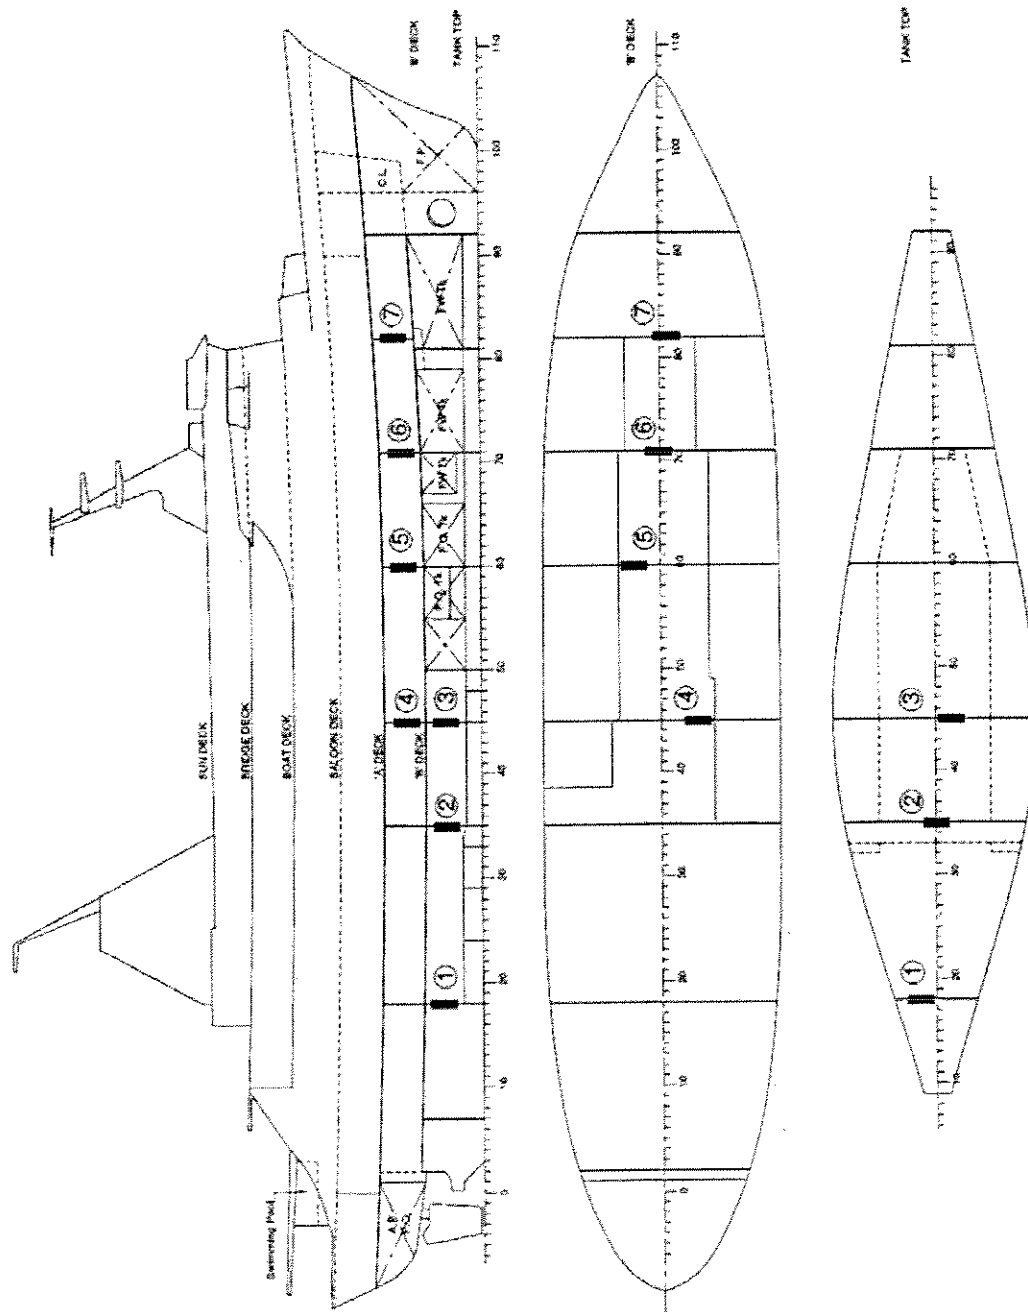
Figure 4.1 ARRANGEMENT OF WATERTIGHT DOORS

The watertight doors are indicated by circled numbers 1 through 7.
